**Flood Control Project Maintenance  
Levee Inspections**

**Fall 2011 Levee Maintenance Deficiency Summary Report**

**Sutter Maintenance Yard Maintenance Area 0001**

**Levee Inspection Report By Mile - Fall 2011**

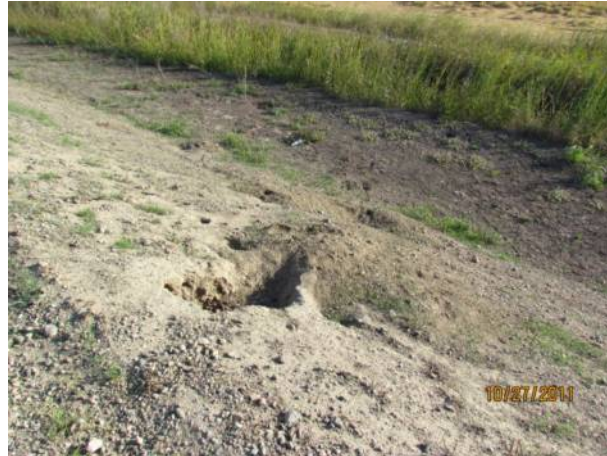
Levee Mile Report Line	5
Start Levee Mile	1.96
End Levee Mile	1.96
Location	Land Side
Category	Earthen Levee
Item	Animal Control

View of the rodent holes along the L/S slope.

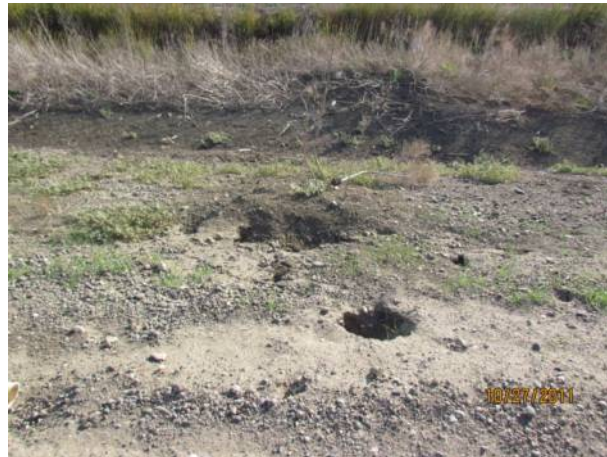
Levee Mile Report Line	6
Start Levee Mile	2.03
End Levee Mile	2.03
Location	Land Side
Category	Earthen Levee
Item	Animal Control

6	2.03	2.03	Earthen Levee	Animal Control	LS	M	No rodents visible, but rodent burrows visible; need to backfill and compact or grout burrows.	39.232728 ° -122.014912 °	39.232728 ° -122.014912 °	467 Y
7	2.31	2.38	Earthen Levee	Encroachments	LS	PO	Fences	39.236327 ° -122.012727 °	39.237215 ° -122.012122 °	5
8	2.57	2.59	Earthen Levee	Trim / Thin Trees	LS	C	Trim and thin trees to allow visibility of the ground and room to flood fight.	39.239609 ° -122.010532 °	39.239846 ° -122.010246 °	6
9	2.57	2.59	Earthen Levee	Trim / Thin Trees	LS	A	Trim and thin trees to allow visibility of the ground and room to flood fight.	39.239609 ° -122.010532 °	39.239846 ° -122.010246 °	474 Y
10	2.58	2.60	Earthen Levee	Encroachments	LS	CO	Buildings	39.239750 ° -122.010390 °	39.239955 ° -122.010090 °	20 Y
11	2.66	2.70	Earthen Levee	Animal Control	LS	M	No rodents visible, but rodent burrows visible; need to backfill and compact or grout burrows.	39.240602 ° -122.009468 °	39.241092 ° -122.009312 °	468 Y

View of the rodent holes along the L/S slope.

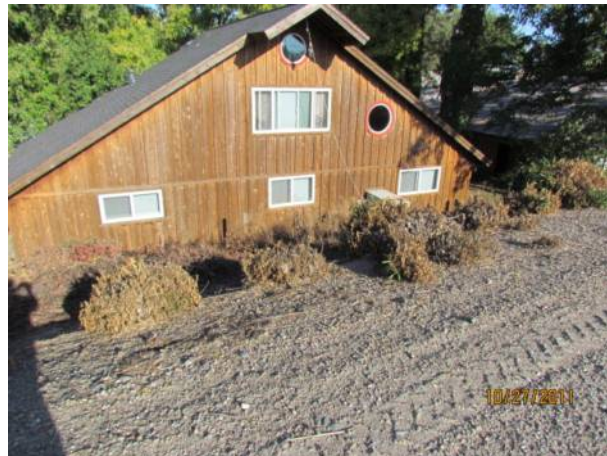
Levee Mile Report Line	9
Start Levee Mile	2.57
End Levee Mile	2.59
Location	Land Side
Category	Earthen Levee
Item	Trim / Thin Trees

View of the trees that has been sprayed along the L/S slope.

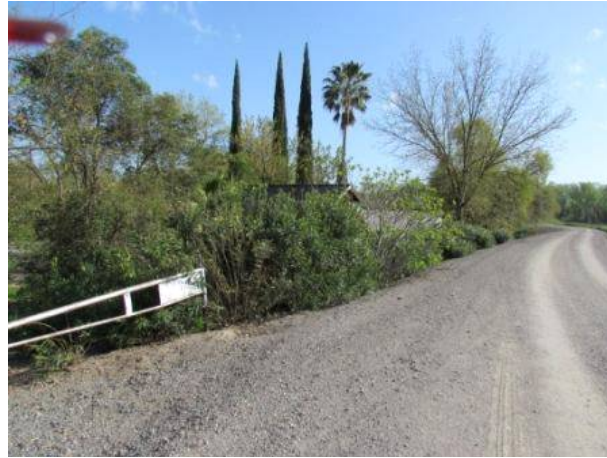
Levee Mile Report Line	10
Start Levee Mile	2.58
End Levee Mile	2.60
Location	Land Side
Category	Earthen Levee
Item	Encroachments

View of the house next to the levee.

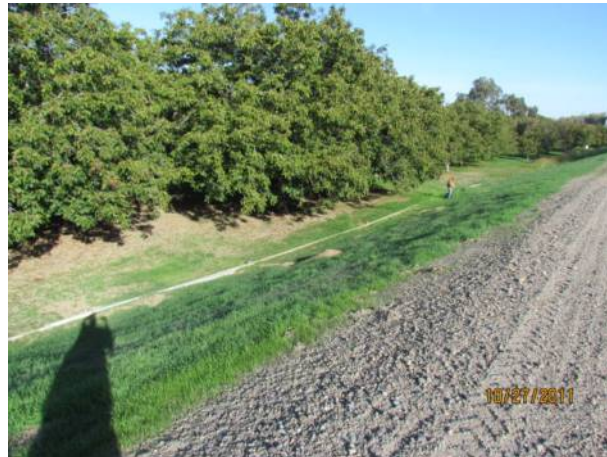
Levee Mile Report Line	11
Start Levee Mile	2.66
End Levee Mile	2.70
Location	Land Side
Category	Earthen Levee
Item	Animal Control

View of the rodent holes along the L/S slope.

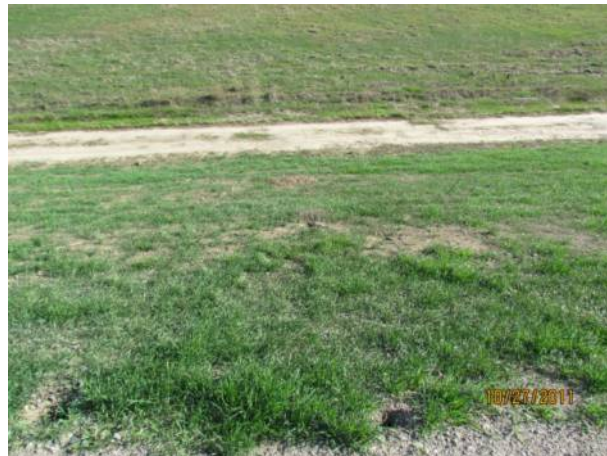
Levee Mile Report Line	13
Start Levee Mile	4.64
End Levee Mile	4.64
Location	Water Side
Category	Earthen Levee
Item	Animal Control

View of the rodent holes along the W/S slope.

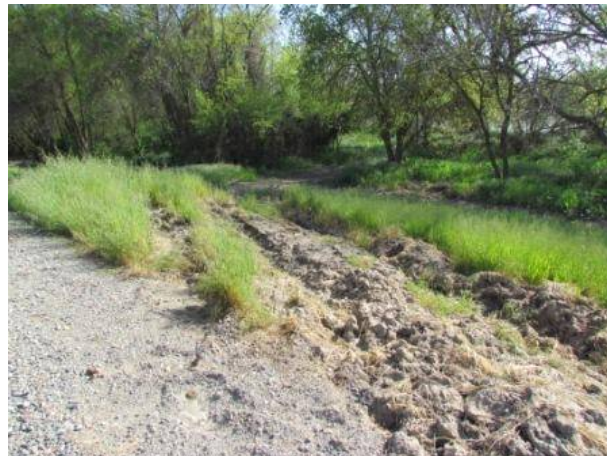
Levee Mile Report Line	15
Start Levee Mile	5.83
End Levee Mile	5.83
Location	Water Side
Category	Earthen Levee
Item	Slope Stability

View of the erosion on the w/s slope.

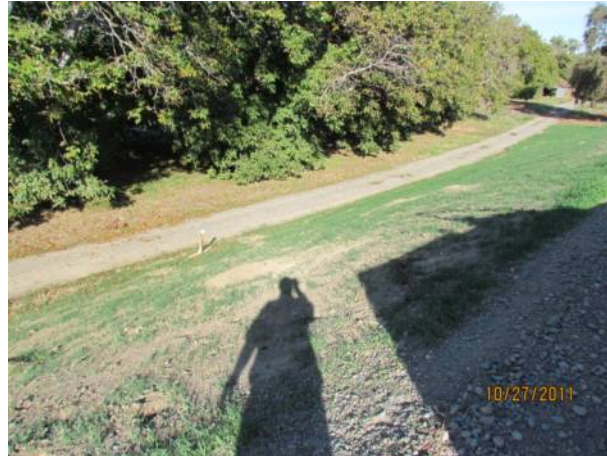
Levee Mile Report Line	17
Start Levee Mile	6.85
End Levee Mile	6.85
Location	Land Side
Category	Earthen Levee
Item	Animal Control

17	6.85	6.85	Earthen Levee	Animal Control	LS	M	No rodents visible, but rodent burrows visible; need to backfill and compact or grout burrows.	39.286117 ° -122.021570 °	39.286117 ° -122.021570 °	470 Y

View of the rodent holes & bait station along the L/s slope.

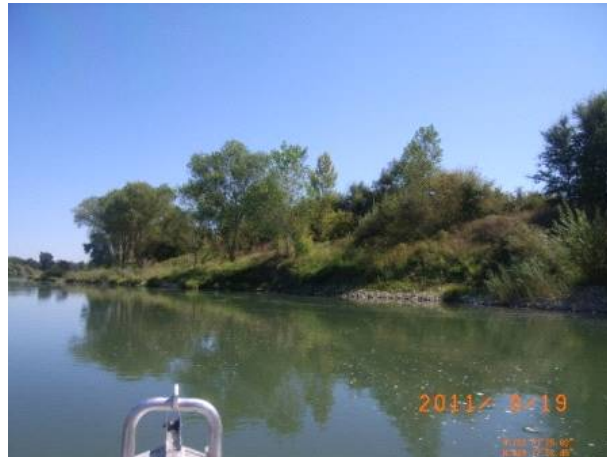
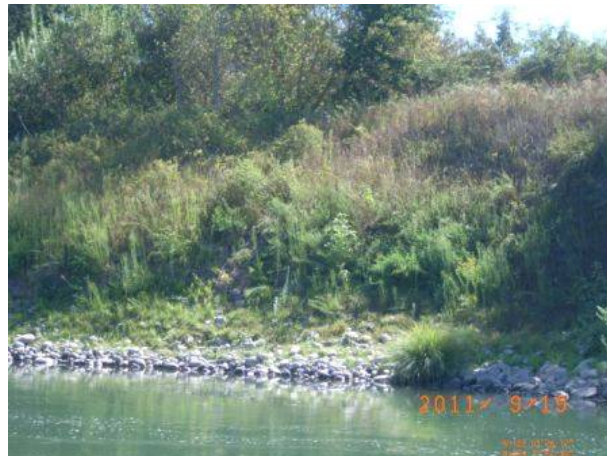
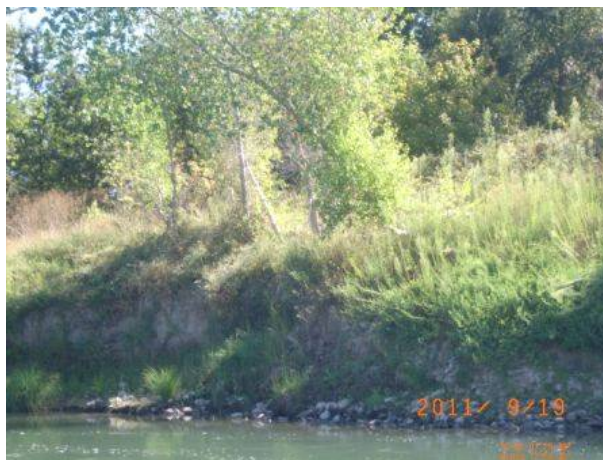
Levee Mile Report Line	18
Start Levee Mile	7.70
End Levee Mile	7.71
Location	Water Side
Category	Supplemental
Item	USACE Erosion Survey

LMR No.	Levee Mile		Category	Item	Location *	Rating **	Action/Comment	GPS Latitude/Longitude		Issue No. Photo
	Start	End						Start	End	
18	7.70	7.71	Supplemental	USACE Erosion Survey	WS	M	Inspector Comments: 2010 - Downstream end of 154.5, needs maintenance, small amount to erosion into the levee toe. 2011: Old cobble site starting to unravel. Some new minor erosion since last year. [2011 Site ID: SAC_154-0_R]	39.297714 ° -122.023728 °	39.297811 ° -122.023354 °	16 Y
19	7.87	7.87	Earthen Levee	Vegetation	WS	M	Elderberries are blocking visibility and flood fight capability.	39.297303 ° -122.025257 °	39.297303 ° -122.025257 °	52
20	9.54	9.54	Earthen Levee	Encroachments	LS	M	Prunings	39.317199 ° -122.030339 °	39.317199 ° -122.030339 °	10
21	10.35	10.35	Earthen Levee	Erosion / Bank Caving	WS	W	Note and monitor erosion site.	39.328697 ° -122.029262 °	39.328697 ° -122.029262 °	18 Y
22	10.46	10.46	Supplemental	USACE Erosion Survey	WS	M	Inspector Comments: 2004 - Slowly eroding but near vertical with no vegetation to hold it. 2005 - Erosion is close to levee toe but not into the levee section yet. 2010 - Some new toe scour. 2011: No observed change. [2011 Site ID: SAC_157-7_R]	39.331447 ° -122.029440 °	39.332716 ° -122.029953 °	17 Y

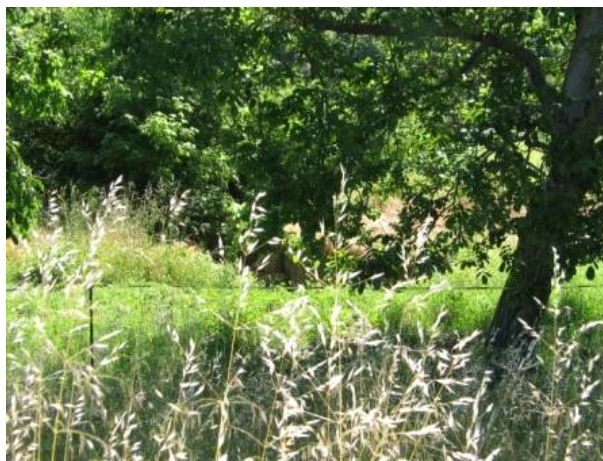
Levee Mile Report Line	21
Start Levee Mile	10.35
End Levee Mile	10.35
Location	Water Side
Category	Earthen Levee
Item	Erosion / Bank Caving

View of the erosion along the waterside of the levee.

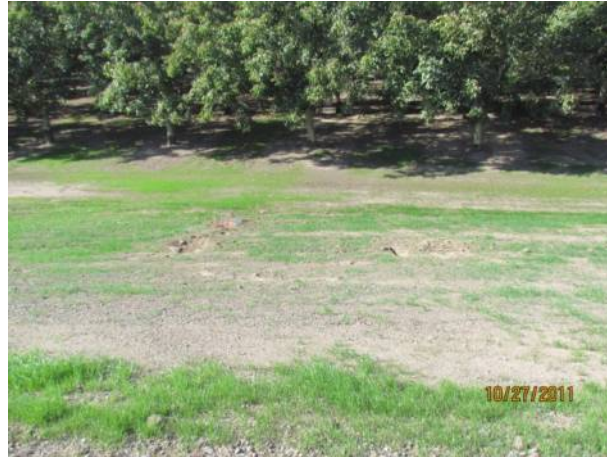
Levee Mile Report Line	23
Start Levee Mile	10.91
End Levee Mile	10.91
Location	Land Side
Category	Earthen Levee
Item	Animal Control

23	10.91	10.91	Earthen Levee	Animal Control	LS	M	No rodents visible, but rodent burrows visible; need to backfill and compact or grout burrows.	39.336025 ° -122.032562 °	39.336025 ° -122.032562 °	471 Y
24	11.25	11.25	Earthen Levee	Trim / Thin Trees	LS	M	Trim trees to at least five feet above ground level.	39.340774 ° -122.032871 °	39.340774 ° -122.032871 °	13
25	11.25	11.25	Earthen Levee	Vegetation	LS	M	Elderberries are blocking visibility and flood fight capability.	39.340774 ° -122.032872 °	39.340774 ° -122.032872 °	12
26	12.00	12.05	Earthen Levee	Encroachments	LS	PO	Landscaping	39.351155 ° -122.030443 °	39.351832 ° -122.030295 °	23
27	12.33	13.38	Earthen Levee	Encroachments	LS	PO	Agricultural Ditch	39.355607 ° -122.028707 °	39.362600 ° -122.014497 °	4
28	13.56	13.56	Earthen Levee	Animal Control	LS	M	Exterminate rodents and backfill and compact or grout burrows.	39.364843 ° -122.015617 °	39.364843 ° -122.015617 °	9

View of the rodent holes along the L/S slope.

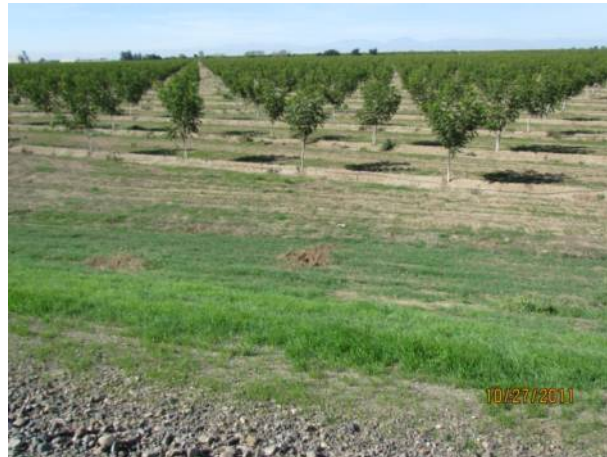
Levee Mile Report Line	29
Start Levee Mile	13.59
End Levee Mile	13.65
Location	Land Side
Category	Earthen Levee
Item	Animal Control

29	13.59	13.65	Earthen Levee	Animal Control	LS	M	Exterminate rodents and backfill and compact or grout burrows.	39.365382 ° -122.015680 °	39.366147 ° -122.015570 °	472 Y
30	16.43	16.43	Earthen Levee	Encroachments	WS	CO	Buildings	39.403930 ° -122.008925 °	39.403930 ° -122.008925 °	14
31	16.45	16.45	Earthen Levee	Encroachments	LS	CO	Buildings	39.404135 ° -122.008797 °	39.404135 ° -122.008797 °	26
32	16.53	16.59	Earthen Levee	Animal Control	LS	M	No rodents visible, but rodent burrows visible; need to backfill and compact or grout burrows.	39.405260 ° -122.008627 °	39.405790 ° -122.008540 °	473 Y
33	16.65	16.68	Earthen Levee	Encroachments	LS	PO	Buildings	39.407066 ° -122.008730 °	39.407363 ° -122.008780 °	15

View of the rodent holes along the L/S toe.

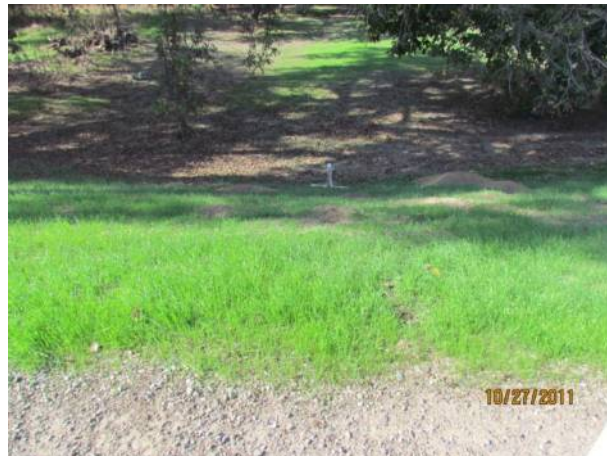
Levee Mile Report Line	32
Start Levee Mile	16.53
End Levee Mile	16.59
Location	Land Side
Category	Earthen Levee
Item	Animal Control

View of the rodent holes along the L/S slope.

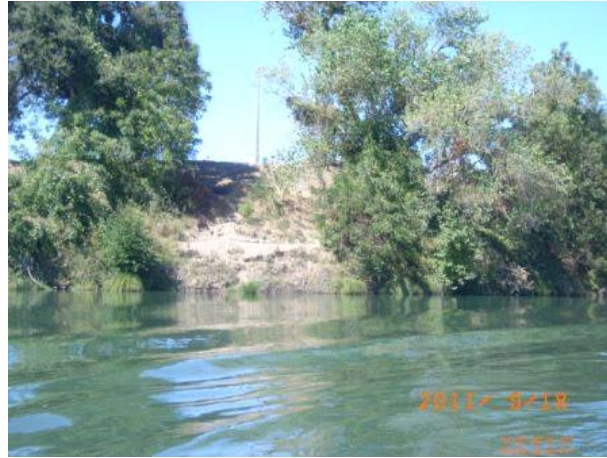
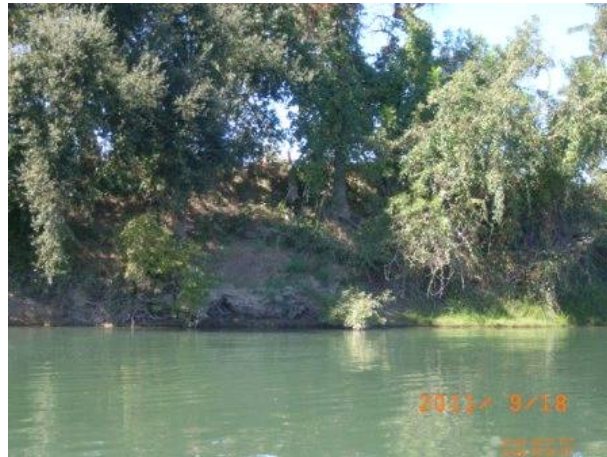
Levee Mile Report Line	34
Start Levee Mile	16.66
End Levee Mile	16.66
Location	Water Side
Category	Supplemental
Item	USACE Erosion Survey

LMR No.	Levee Mile		Category	Item	* Location	** Rating	Action/Comment	GPS Latitude/Longitude		Issue No.
	Start	End						Start	End	Photo
34	16.66	16.66	Supplemental	USACE Erosion Survey	WS	M	Inspector Comments: Erosion site added in 1997 and removed in 2005. 2009 - Site added back in, hard toe with slow moving erosion. Potential geotechnical failure. 2011: Site extended downstream. [2011 Site ID: SAC_164-3_R]	39.407837 ° -122.008763 °	39.411111 ° -122.009238 °	19 Y
35	16.66	16.69	Earthen Levee	Encroachments	LS	CO	Buildings	39.407225 ° -122.008570 °	39.407545 ° -122.008640 °	46
36	16.70	16.71	Earthen Levee	Encroachments	LS	CO	Fences	39.407670 ° -122.008685 °	39.407823 ° -122.008740 °	47
